# SELECTED ENGINEERING PROBLEMS

## STATISTIC ANALYSIS OF DATA FROM RENOVATIONS OF FREIGHT WAGONS

**Abstract:** Analysis of data from protocols that are filled during the process of qualification for renovation of freight wagons can be very useful in the process of freight wagons development and modernization in order to obtain better exploitation properties and extend periods between repairs. In this paper results for freight wagon types EAOS 1415 A2 and A3 as well as BDZE, CFRE, CSDE, 401W, 408W, 412W are presented. 298 qualification protocols from years 2012 up to 2014 were analysed. The acquired data were analysed in order to specify the percentage of repairs of individual wagons elements. Obtained results were presented on charts. It was concluded that at this moment there is no any part of the freight wagons body shell that may be indicated as the most exposed to damage during standard exploitation of the freight wagons.

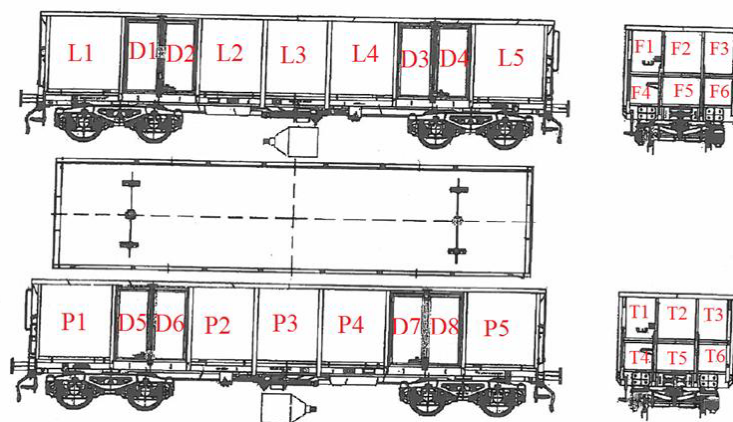
In order to analyse data from protocols elements of the freight car's box were named and marked on the scheme of the freight wagon. In Fig. 1 names of the EAOS 1415 A2 and A3 wagon's elements designations are presented.

Fig.1. Designation of EAOS 1415 A2 and A3 wagon's elements

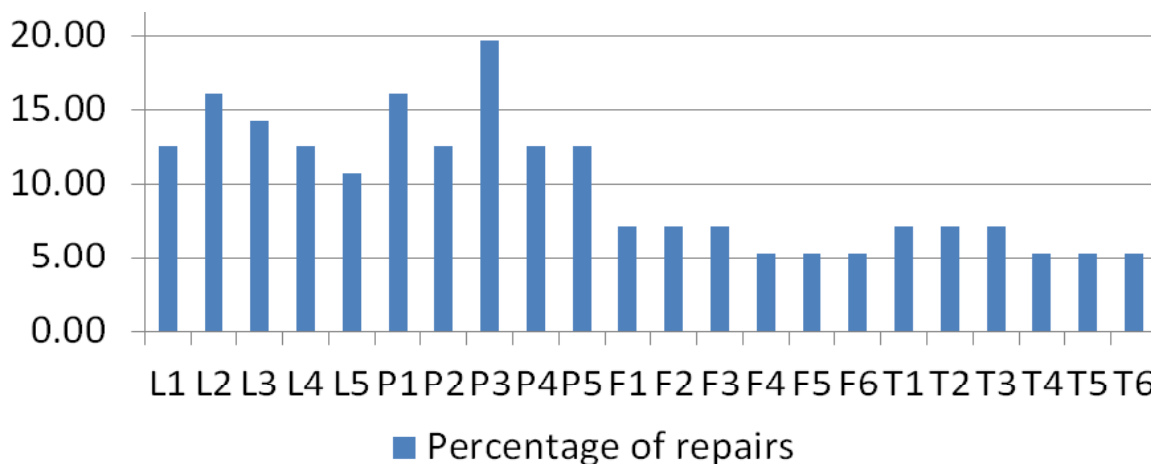
The most important, taking into account assumption of modernization of the freight wagons using composite panels mounted to the wagon's shell of the body, is the information about the damage of its elements. Percentage of repairs of individual elements of the shell of the body is presented in Fig. 2.

Fig.2. Percentage of repairs of individual elements of the shell of the body of freight wagon EAOS 1415

Presented results of qualifying protocols analysis shows that there is no any part of the freight wagons body shell that may be indicated as the most exposed to damage during standard exploitation of the freight wagons. In case of type EAOS 1415 freight wagons it can be noticed that elements of the side walls were repaired more often than elements of front walls but it must be noticed that in this case only 56 qualifying protocols were analysed. In the second case of the freight wagons with very similar structure of the shell of the body such as BDZE, CFRE, CSDE, 401W, 408W, 412W where 221 qualifying protocols were analysed the distribution of the percentage of repairs of individual elements is much more uniform. It should be mentioned that in order to obtain more precise information about the process of damage of individual elements of the freight wagons body shell during their exploitation it is necessary to carry out a more accurate operational documentation starting from the production of wagons, which will take into account operating conditions of carriage, such as the type of transported cargo, as well as all carried out repairs. Results of the implementation of the improved qualifying protocols will be presented in the future publications.

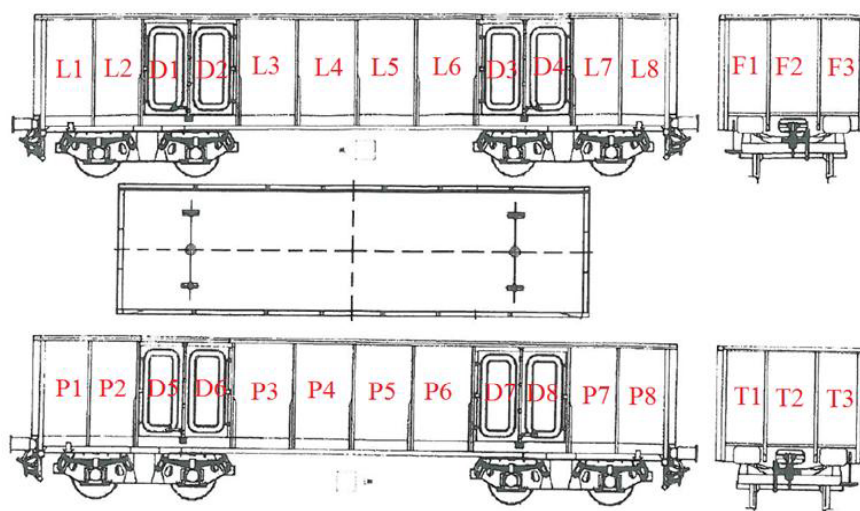
In Fig. 3 assigned names of elements of the freight wagons marked BDŽE, CFRE, CSDE, 401W, 408W, 412W are presented. Such kind of freight wagons have very similar structure of the shell of the body and 221 qualifying protocols of those wagon types were analysed. Obtained results are presented in Fig. 4.

Fig.3. Designation of BDŽE, CFRE, CSDE, 401W, 408W, 412W wagon's elements

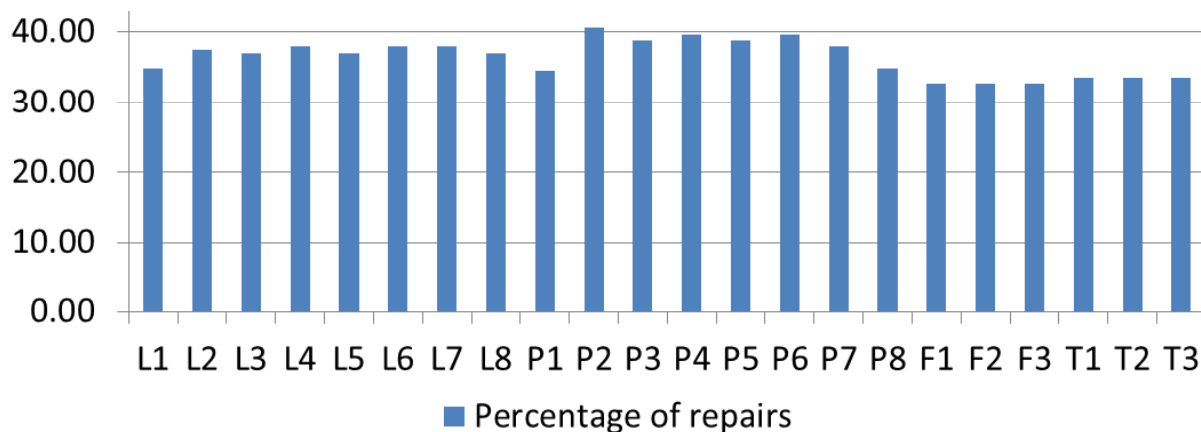
In case of all analysed qualifying protocols they were prepared before the standard periodical renovation of freight wagons that takes place every three years of their exploitation.

Fig.4. Percentage of repairs of individual elements of the shell of the body of freight wagon BDZE, CFRE, CSDE, 401W, 408W, 412W
